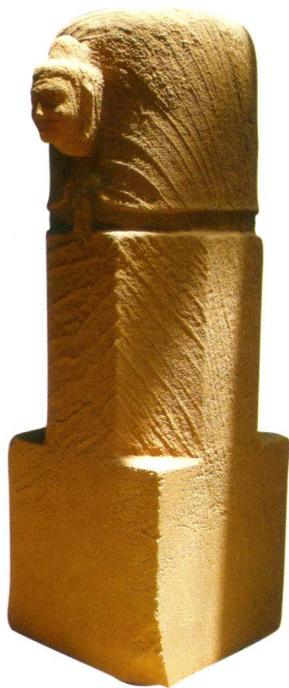
Fig. 7 Ekamukhalinga found in 2012 in My Son E1 temple. (Photo: Trần Kỳ Phương)

In November 2012, the staff of the Management Board of the Mỹ Sơn Site accidentally uncovered a buried *ekamukhalinga* (*linga* with Śiva's face, Fig. 7) at the northeast outer corner of the Mỹ Sơn E1 temple. Art historians believe the 120cm high *linga* is the one Parmentier first thought must have been erected in the temple (Trần Kỳ Phương, Nguyễn Công Khiết, Lê Văn Minh 2016: 786-90). Two roof tiles carved with carved *kāla* faces were also discovered, adding to the evidence for seeing the temple as roofed with terracotta tiles.

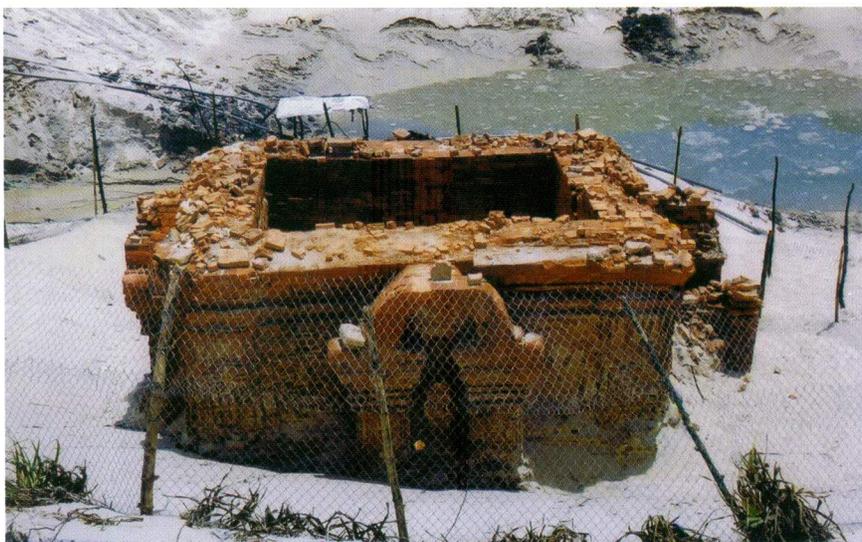
Fig. 8 Mỹ Khánh temple shortly after its discovery. (Photo: Trần Kỳ Phương)

The closed-sanctum type of temple appeared when the Cham began to apply the corbel technique. A typical example of this type is the Mỹ Khánh temple, discovered in Huế in 2001. Its position is unique among Cham temples (Fig. 8).

Mỹ Khánh temple, which faces east, was built on a small scale with the walls approximately 270/290 cm high, 150 cm thick and 600 cm long. There are three 'false-door' carved arches with uncompleted human figures standing on lotus flowers. The excavating team from the Vietnam Institute of Archaeology and the Provincial Museum of Thừa Thiên-Huế reported that,

...the excavation of the interior of the tower and the area outside its walls revealed no evidence of collapse.... Thus it is very possible that the Mỹ Khánh tower caved in because it was built on ground that was not solid ... so that construction work on the top of the temple was halted and the structure was only used on a temporary basis. (Trịnh Nam Hải 2001: 80-1)

It has been speculated that the temple was a simple building with a roof of light material such as grass or wood. Evidence supporting this argument is the discovery of a small brick pillar-base (31×19 cm, 18 cm high) at the southwest interior corner of the temple. A base of this size could only have supported a very small wooden or bamboo pillar. Furthermore, in a picture taken just after the discovery of Mỹ Khánh tower in May 2001, one can see very clearly the well-finished surfaces of the very top line of the brick tower walls, showing that the tower was built without a brick roof. The evidence from Mỹ Sơn E1 and Mỹ Khánh suggests that the Cham builders gradually constructed brick temples on a higher and higher scale, evolving from the lower walls of Mỹ Sơn E1 to the higher ones of Mỹ Khánh.⁷ It may be speculated that at that time the roofs were still made of wood or grass.
